Manhole Inspection Summary

Manhole # S29G__054MH

Insp Date: **8/4/08 11:42 AM**

Location Address: **630 fayette st**

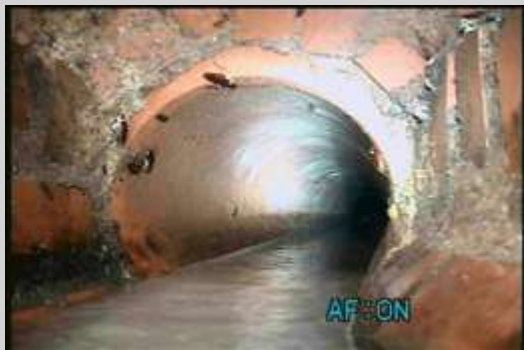
12 O'Clock Outflow

12 in. Circular Gravity Sewer
Pipe Out @ 12 O'Clock

Pipe Material: **Clay** ☐ Pipe Lined

Invert Depth: **10.33** (ft.) Flow Characteristics: **Fast**

Deposits: ☒ None ☐ Mud ☐ Sludge ☐ Debris ☐ Grease

Infiltration: **None** Pipe Seal Cond: **Unknown**

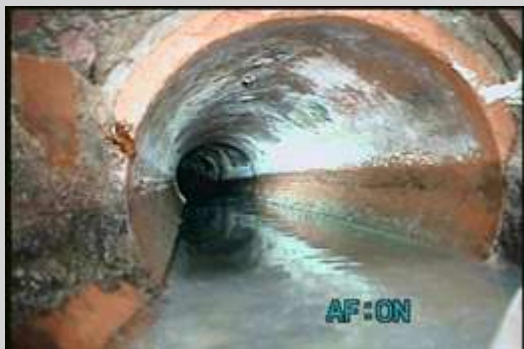
4 O'Clock Inflow

10 in. Circular Gravity Sewer
Pipe In @ 4 O'Clock

Pipe Material: **Clay** ☐ Pipe Lined

Infiltration: **None** Pipe Seal Cond: **Unknown**
